**Metallurgical Examination of
Soldered Pipe Joints**

March 7, 2006

Exponent analyzed two pipe joints recovered from the Marino carriage house fire that occurred on December 20, 2002. Both pipe joints were soldered at some point prior to the fire, but were found separated under the kitchen sink after the fire. The purpose of the analysis conducted by Exponent was to determine when these two soldered joints were separated.

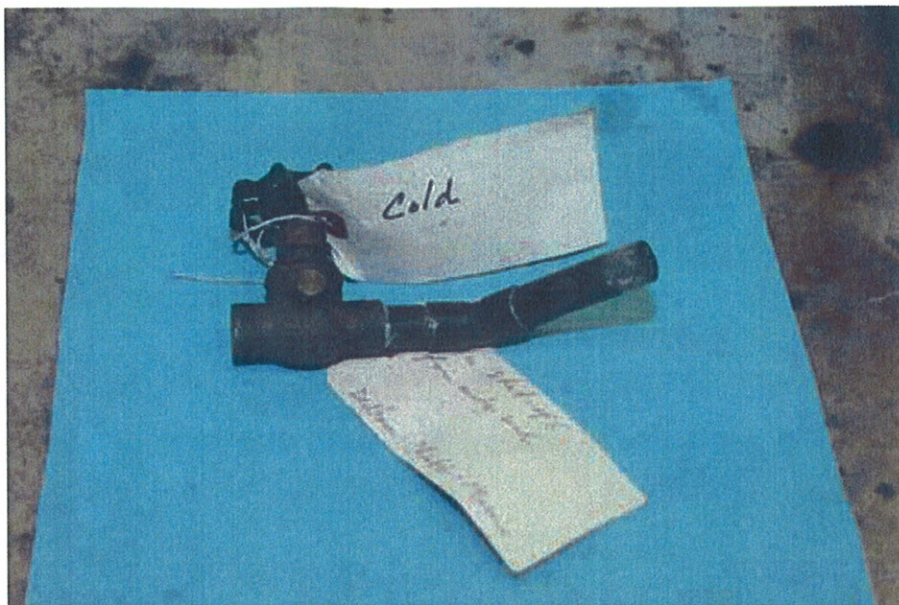
On December 20, 2002, a fire damaged the carriage house owned by Mr. Marino in Dedham, Massachusetts. The kitchen was among the rooms in the carriage house that incurred damage from the fire. The support structure surrounding the kitchen sink was weakened by the fire damage and resulted in the collapse of the sink. Upon investigation of the kitchen area, the sink was removed and water piping under the sink was inspected. One segment of piping from the cold water supply line was found separated from the other piping. This segment consisted of a brass valve soldered to a section of copper tubing, and is shown in Figure 1. The original location and orientation of this segment under the sink is shown in Figure 2.

The separated female portion of the brass valve shown in Figure 1 was originally soldered to the vertical section of copper tubing shown in Figure 3, and the copper tube was soldered to the brass compression fitting shown in Figure 4. The brass compression fitting was threaded onto a plastic-lined, flexible, braided stainless steel hose. This braided hose can also be seen in Figure 4.

Figure 1. Photograph of the detached valve and connected copper tube. A photograph of the corresponding male fitting is shown in Figure 3 and the corresponding female fitting is shown in Figure 4.

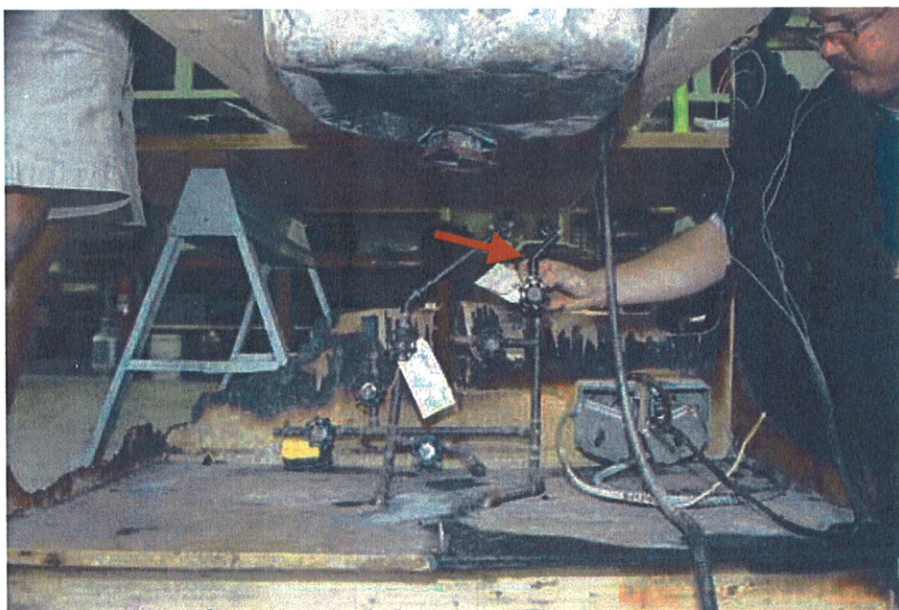
Figure 2. Photograph showing the area under the kitchen sink where the detached valve and connected copper tube would have been located prior to the fire. The red arrow denotes the separated brass valve/copper tube assembly shown in Figure 1.
